Kiwiprops™

Kiwi Feather Props Ltd

CUSTOMER MANUAL

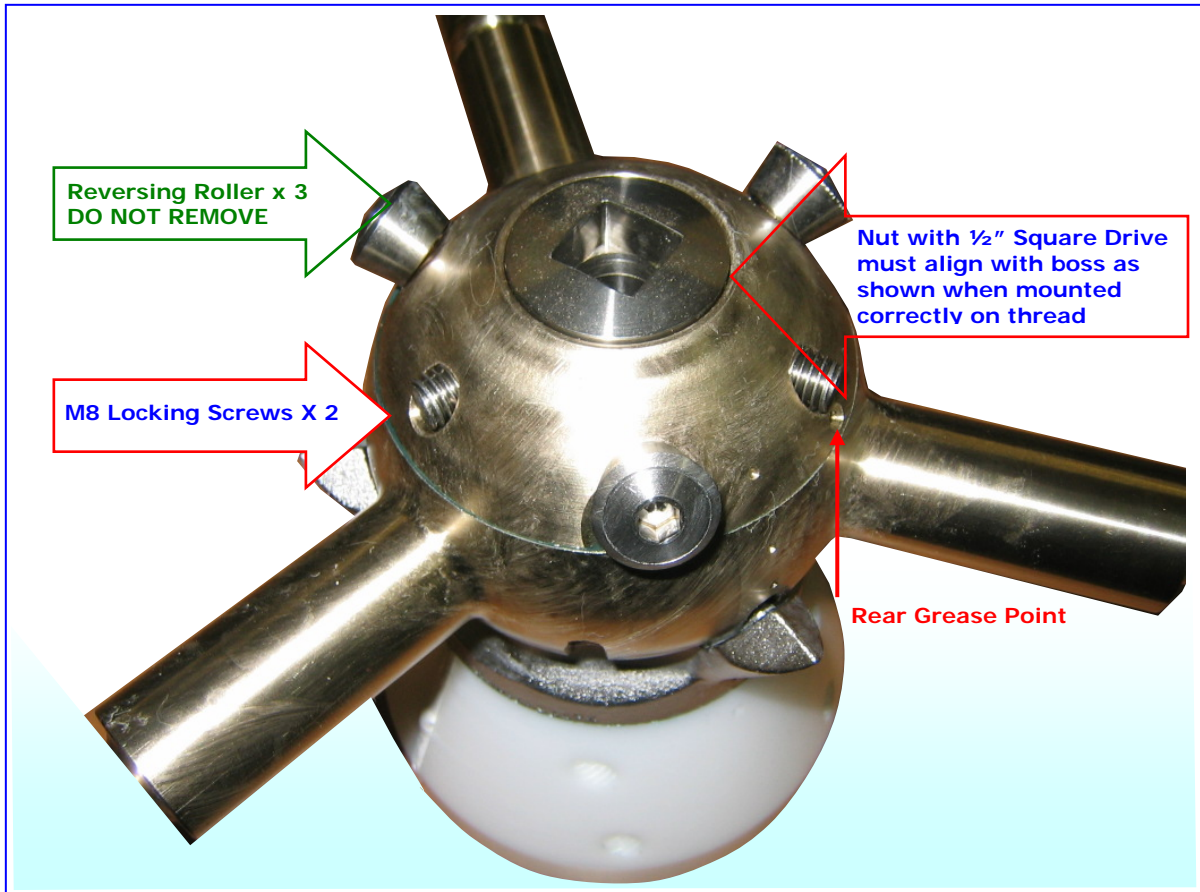
The photograph below shows a boss without the blades attached and clearly identifies the nut with its ½" square drive recess and the two M8 locking screws that must first be backed off to allow for removal of the nut from the unit. **Also apply Loctite™ to the thread on the nut.**

Apply a drop of Loctite™ to the 2 x M8 Locking screws shown above located on the hub of your Kiwiprop which are used to then lock the nut onto the shaft using the appropriate Allen key. Also apply Loctite™ to the retaining nut on Saildrive installations.

Refer first to exploded diagram on page 9 below and to the picture of the boss on page 2

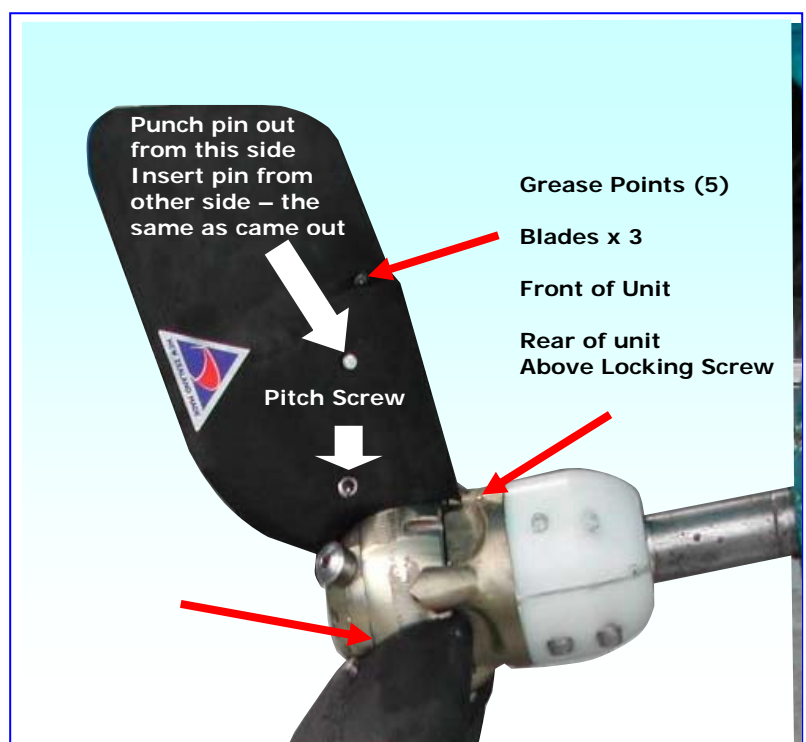
The *Kiwi Feather Prop™* contains lubricants sufficient until your next maintenance haulout. Each blade must then be greased via a lubrication point accessed by removing the small Pozidrive stainless screw on the blade face. In addition there are two small grease holes, one very close to the Delrin™ nose cone in the bronze casting that takes the thrust of the pitch screws and one near the outer perimeter of the bronze sphere at the rear of the unit. These have been chamfered to accept a standard needle nosed grease point. You will need to remove the outer guard off the needle. Each of these five grease points should then be filled with a high quality marine grease eg Shell™ Nautilus Marine Grease - NLGI No 2.

Check the reversing rollers are free to turn and free up if necessary

Check the blade has been remounted on it's old pin. Now mount the retaining pin back into the reverse face of the blade from the side it came out of with a new wear face on the pin facing outwards. By tapping gently - reinsert the pin so that it is equidistant from each outer face of the blade. Refer photograph above for illustration.

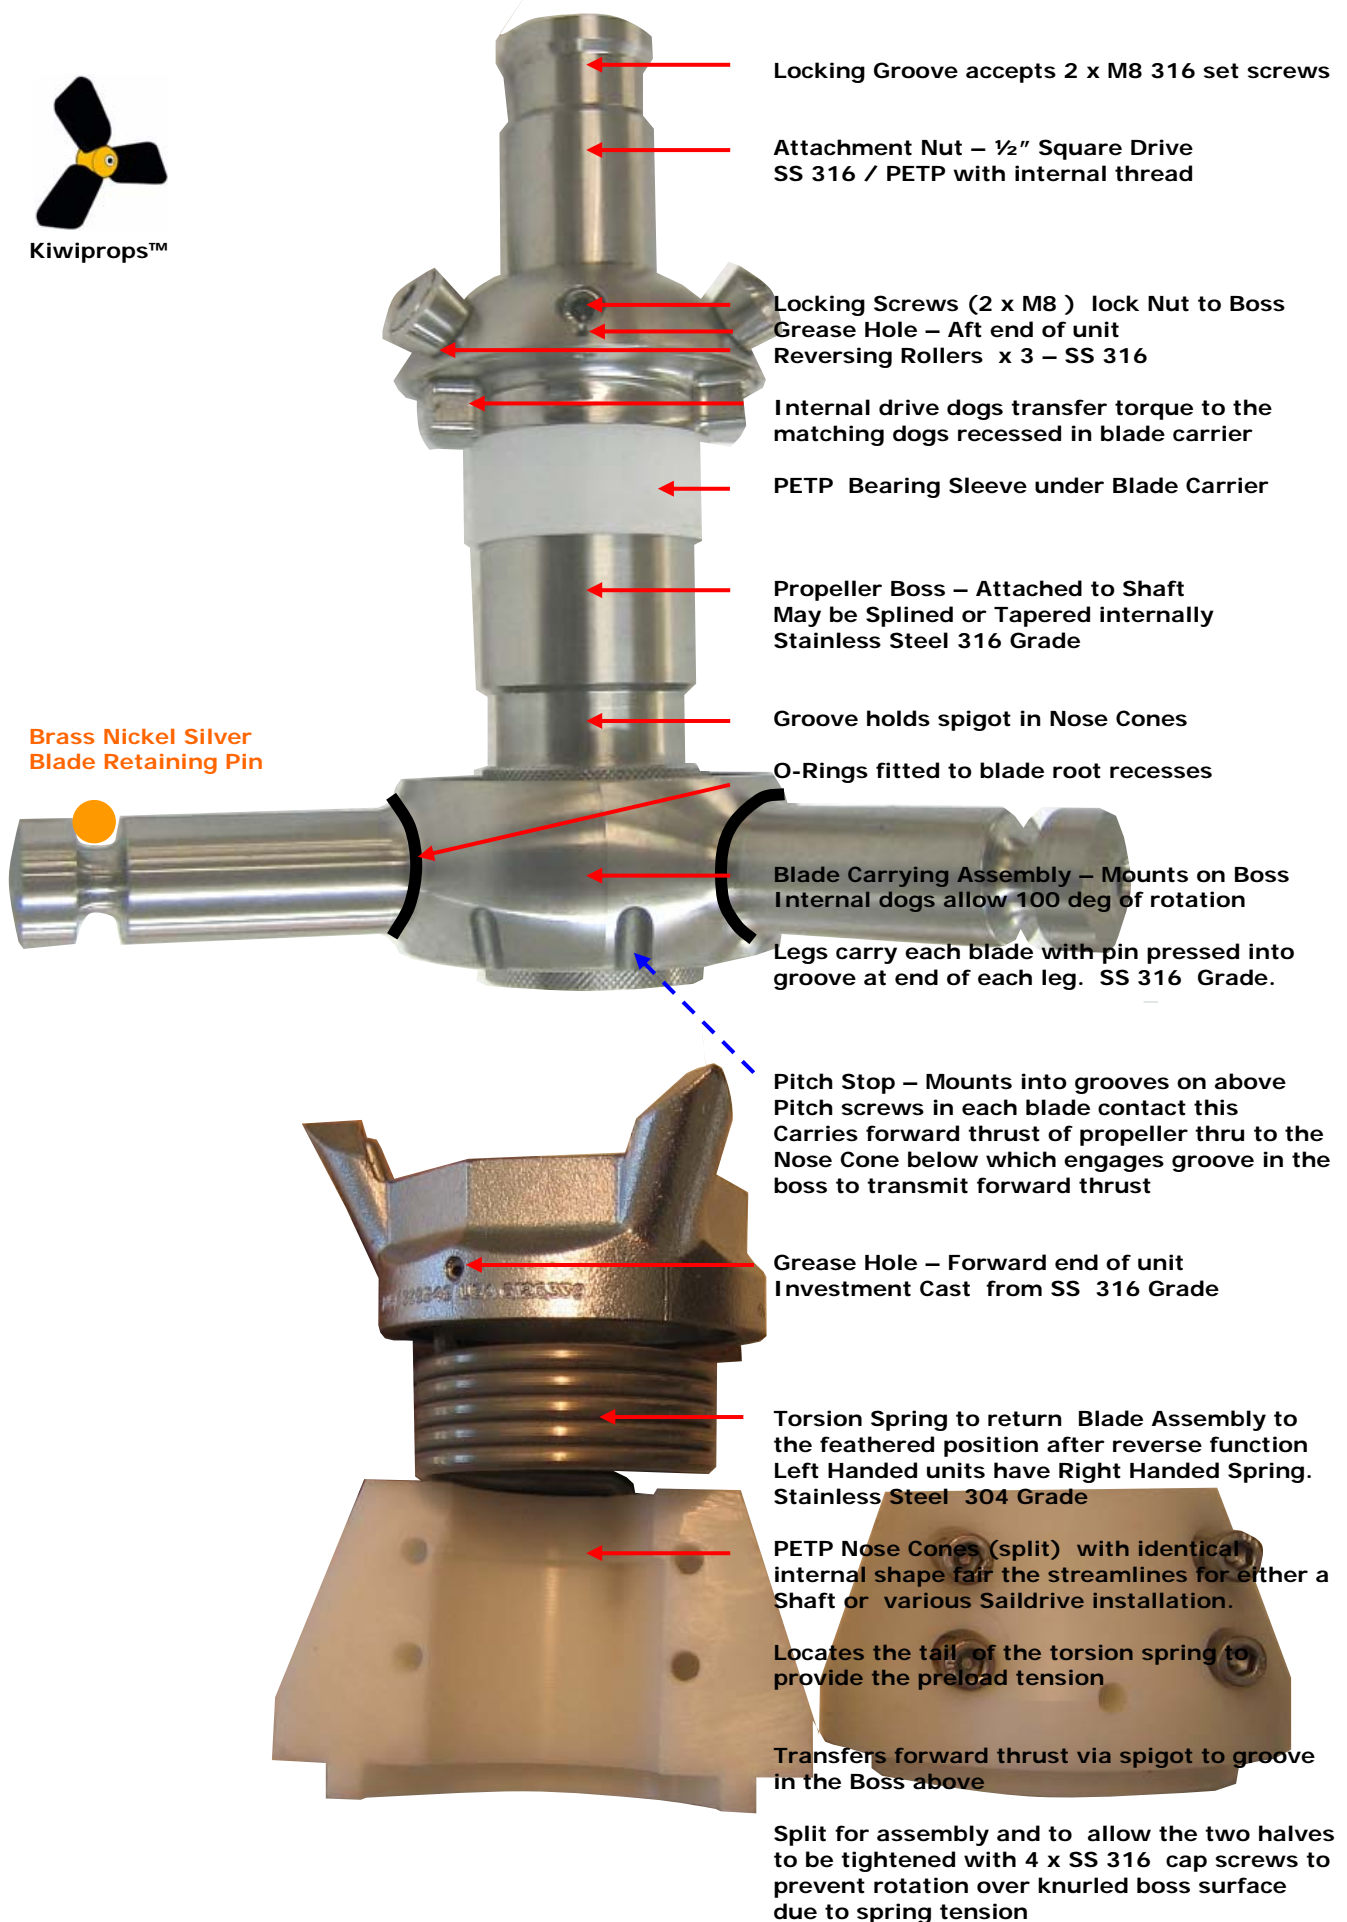
EXPLODED COMPONENTS DIAGRAM:

Locking Groove accepts 2 x M8 316 set screws

Attachment Nut – ½” Square Drive
SS 316 / PETP with internal thread

Locking Screws (2 x M8) lock Nut to Boss
Grease Hole – Aft end of unit
Reversing Rollers x 3 – SS 316

Internal drive dogs transfer torque to the
matching dogs recessed in blade carrier

PETP Bearing Sleeve under Blade Carrier

Propeller Boss – Attached to Shaft
May be Splined or Tapered internally
Stainless Steel 316 Grade

Groove holds spigot in Nose Cones

O-Rings fitted to blade root recesses

Brass Nickel Silver
Blade Retaining Pin

Blade Carrying Assembly – Mounts on Boss
Internal dogs allow 100 deg of rotation

Legs carry each blade with pin pressed into
groove at end of each leg. SS 316 Grade.

Pitch Stop – Mounts into grooves on above
Pitch screws in each blade contact this
Carries forward thrust of propeller thru to the
Nose Cone below which engages groove in the
boss to transmit forward thrust

Grease Hole – Forward end of unit
Investment Cast from SS 316 Grade

Torsion Spring to return Blade Assembly to
the feathered position after reverse function
Left Handed units have Right Handed Spring.
Stainless Steel 304 Grade

PETP Nose Cones (split) with identical
internal shape fair the streamlines for either a
Shaft or various Saildrive installation.

Locates the tail of the torsion spring to
provide the preload tension

Ensure the alignment marks are now correctly located as per the diagram on page 9.

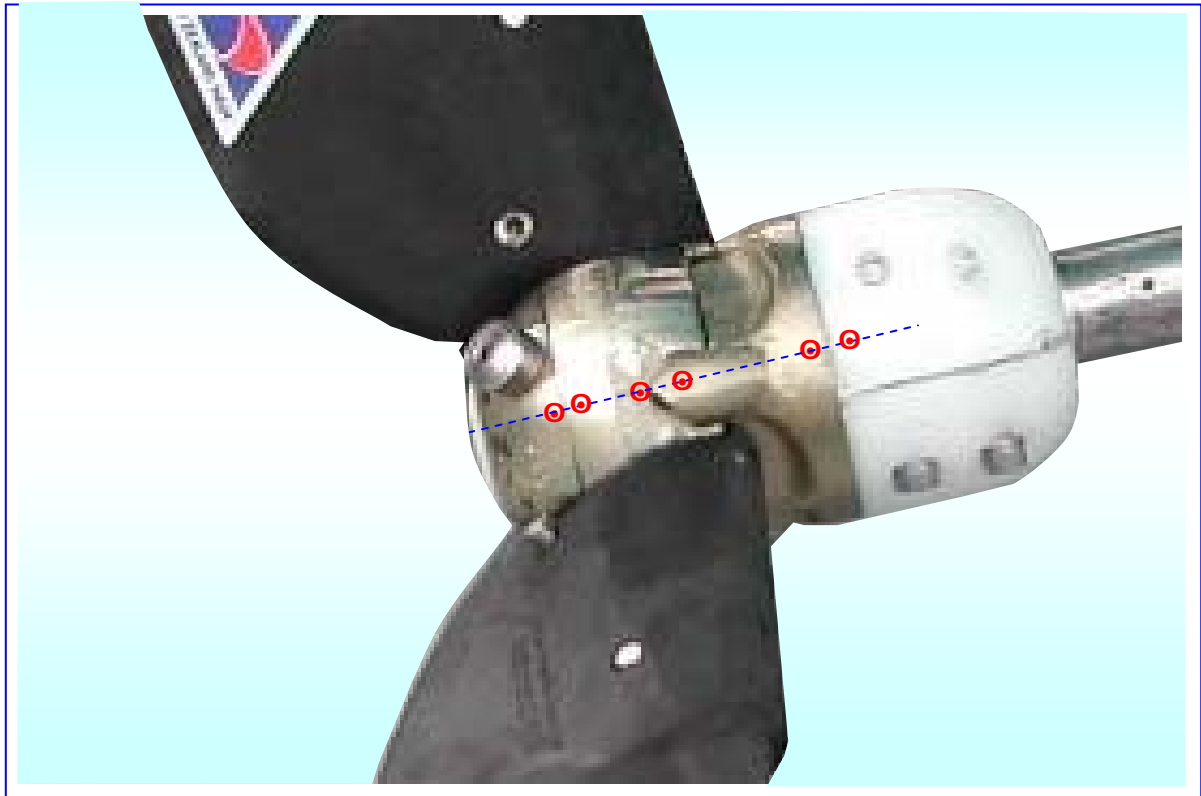
These extend from the Boss to the Blade Carrier down the leg of the tripod that is in line with these marks and then to the small hole drilled just as an indentation on the nose cone adjacent to the mark on the tripod.

The correct re-assembly of the unit will require that all these marks are re-aligned after final assembly including the correct pre tensioning of the torsional spring inside the unit.

WARNING: Customers are strongly advised not to attempt to disassemble the unit unless this becomes absolutely essential. Re-assembly of all the components coupled with the need to ensure sealant is inserted into the nose cone whilst at the same time preloading the internal torsion spring makes for a tricky operation, particularly if no stub shaft is available to hold the unit whilst these operations are completed.
